MAINTENANCE RESPONSE: 11KV FAULT REPAIR ON A CONTRACTED CUSTOMER NETWORK

West Midlands

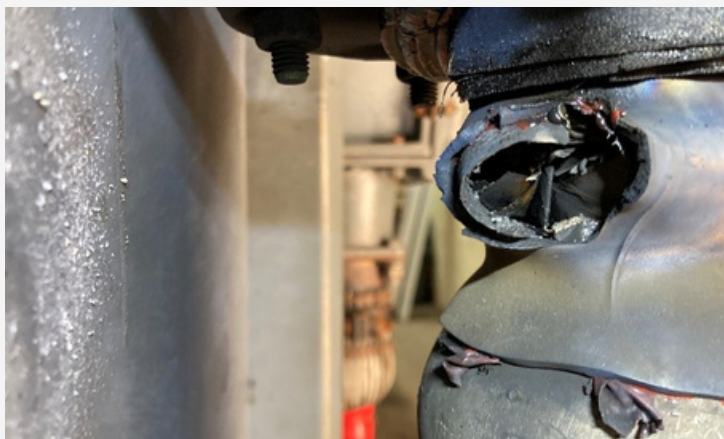
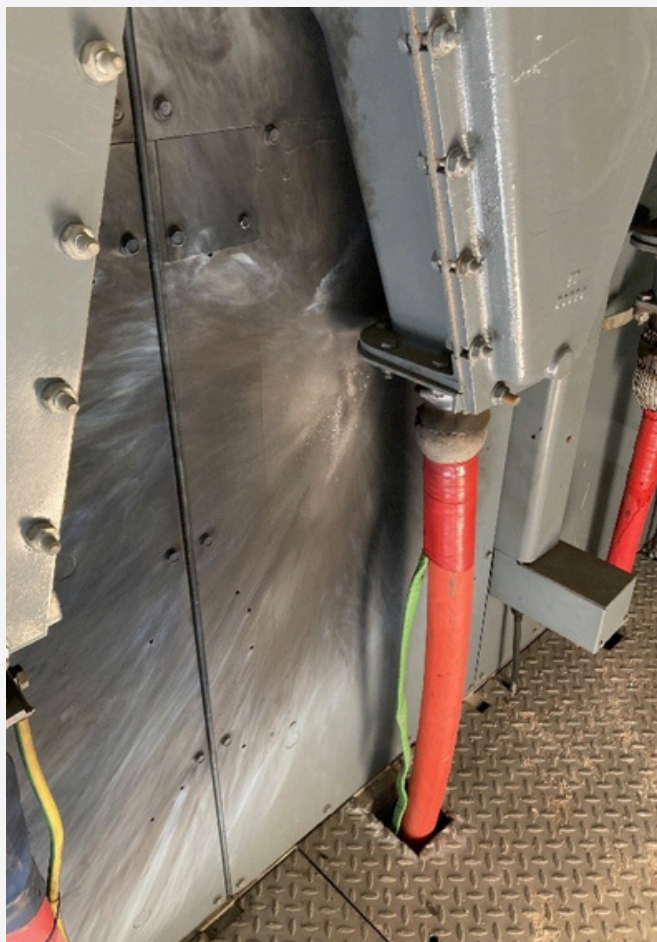
Upon attendance, the IUS Senior Authorised Person (SAP) identified an 11kV cable fault immediately below the cable box of the Transformer No.3 Circuit Breaker. We implemented a safe system of work, in accordance with IUS Distribution Safety Rules and progressed the repair through to completion, testing and restoration of supplies.

IUS received a call from a contracted customer at their manufacturing site following an interruption to their electricity supply. An SAP was immediately dispatched to respond to the customer fault. On arrival our SAP identified the fault and made the situation safe by providing the required isolations. This allowed IUS to proceed with an investigation and found that the 11kV cable had disruptively failed below the cable box on the 11kV Circuit Breaker feeding Transformer No.3.

In consultation with the client, it was explained that a section of the 11kV cable would need replacing. This resulted in the existing 11kV cable being cut in a suitable position so the termination could be disconnected and removed. The SAP arranged for an IUS jointing and fitting team to attend site and the faulty cable was removed. A new 11kV triplex cable was installed and terminated to the cable box, and an 11kV joint was completed in accordance with IUS procedures. The cable box was filled with Guro flex as it was an old-style box, which would not provide the required clearances for an air termination.

The new 11kV cable installation was tested, and a post fault maintenance was completed on the 11kV Circuit Breaker, before restoring the supply back to normal. Liaison with our customer was vitally important, whilst the work was undertaken. This included our SAP returning to site to change over the customer supplies from a temporary generator to its normal supply.
